TENNESSEE VALLEY AUTHORITY
DIVISION OF WATER CONTROL PLANNING

FLOODS ON BRUSH CREEK
IN VICINITY OF
JOHNSON CITY TENNESSEE

REPORT NO. 0-5868

KNOXVILLE TENNESSEE
JUNE 1959

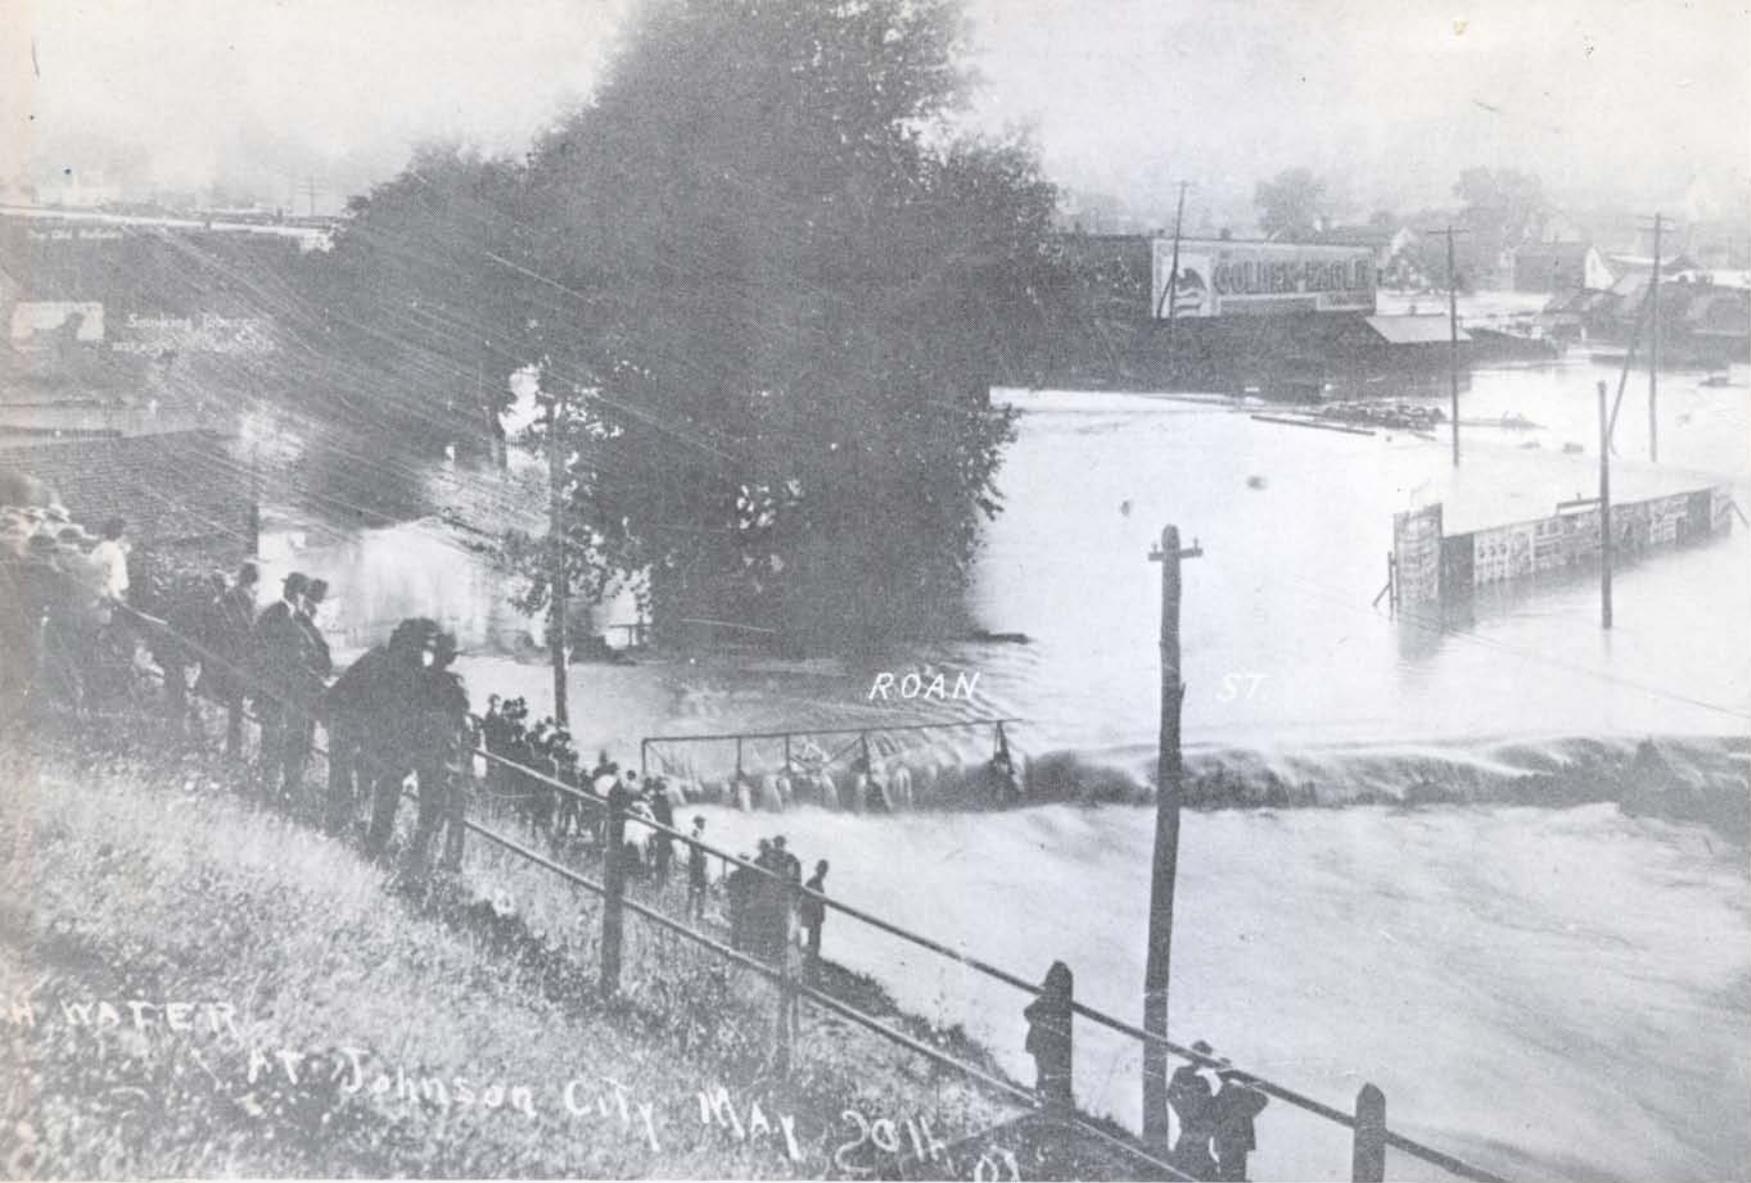
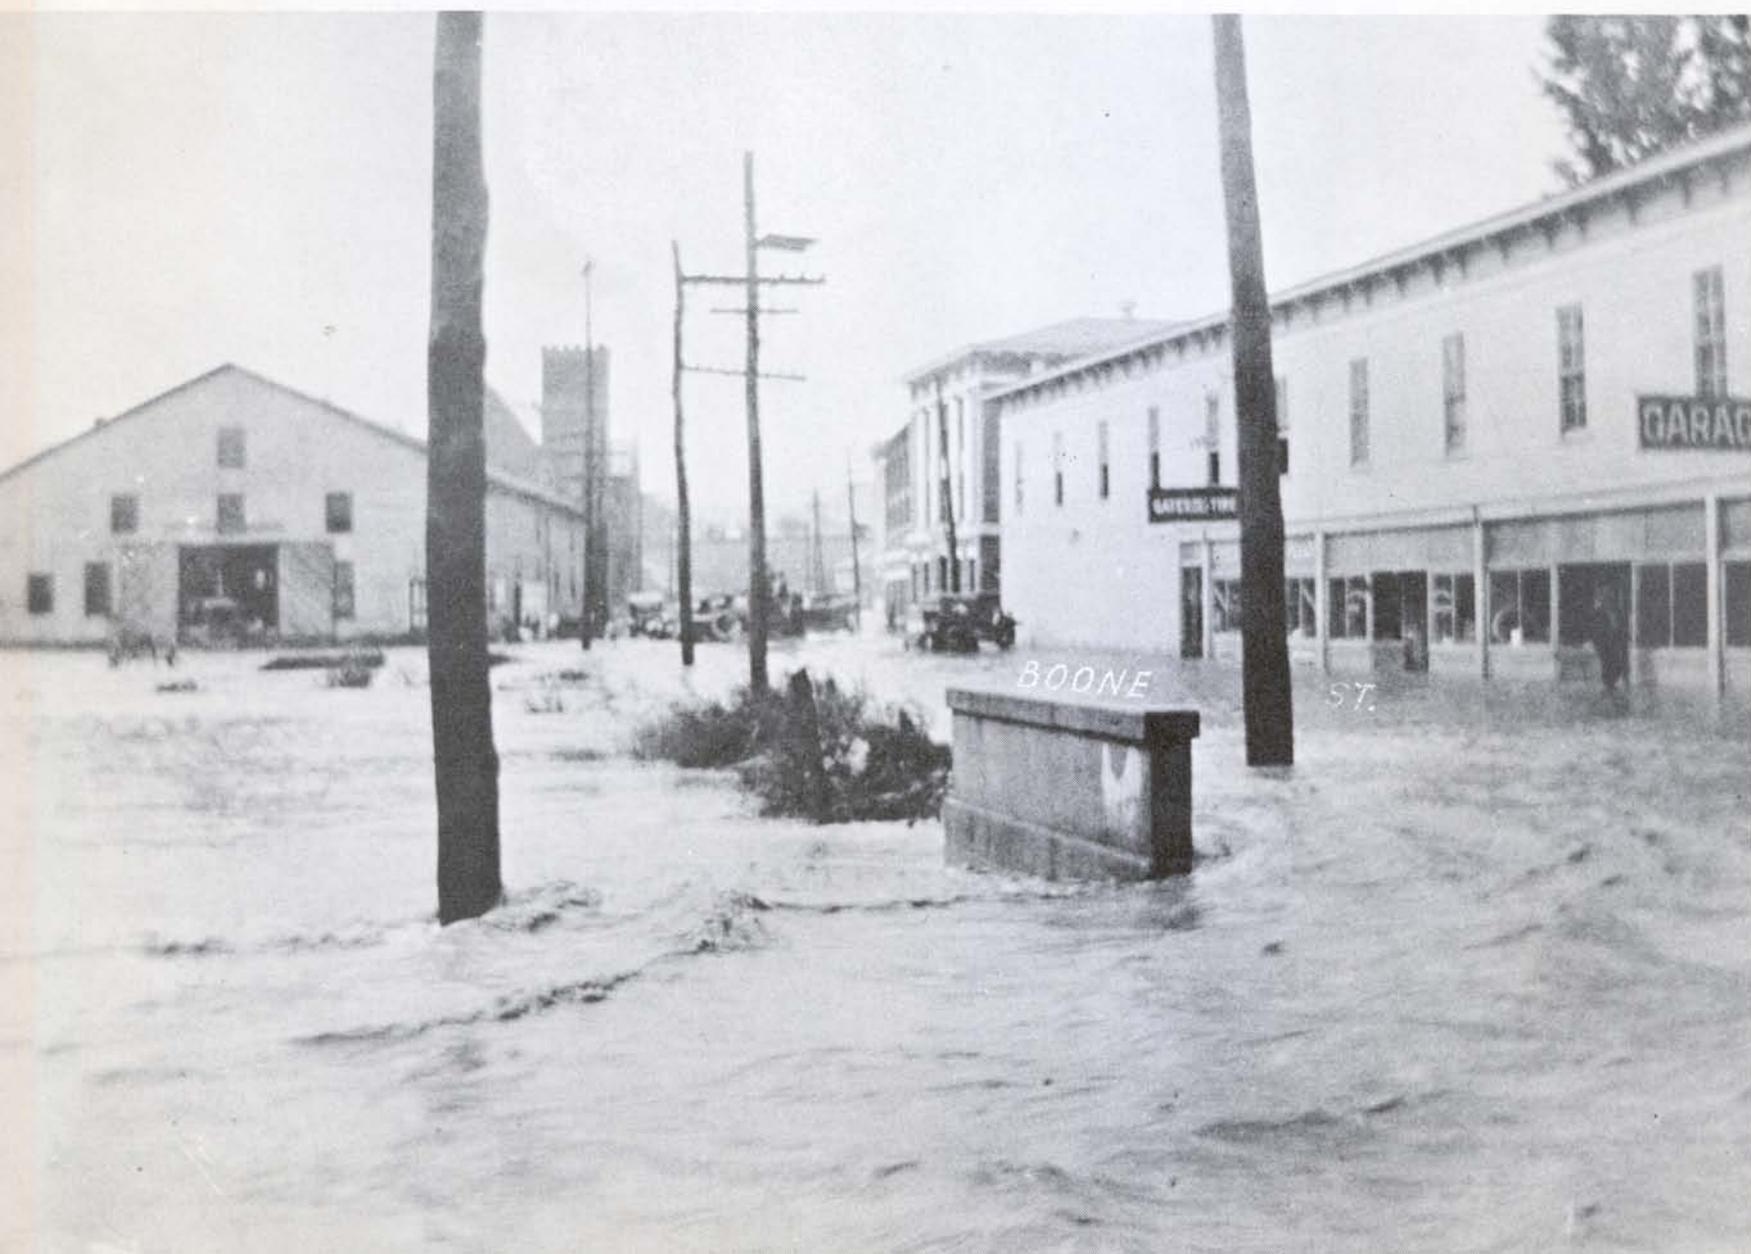
The upper view shows Brush Creek overflowing its flood plain along Roan Street which crosses the creek on the bridge near the center of the picture. The lower view is south along Boone Street toward Market Street. The building with the columns is the City Hall.

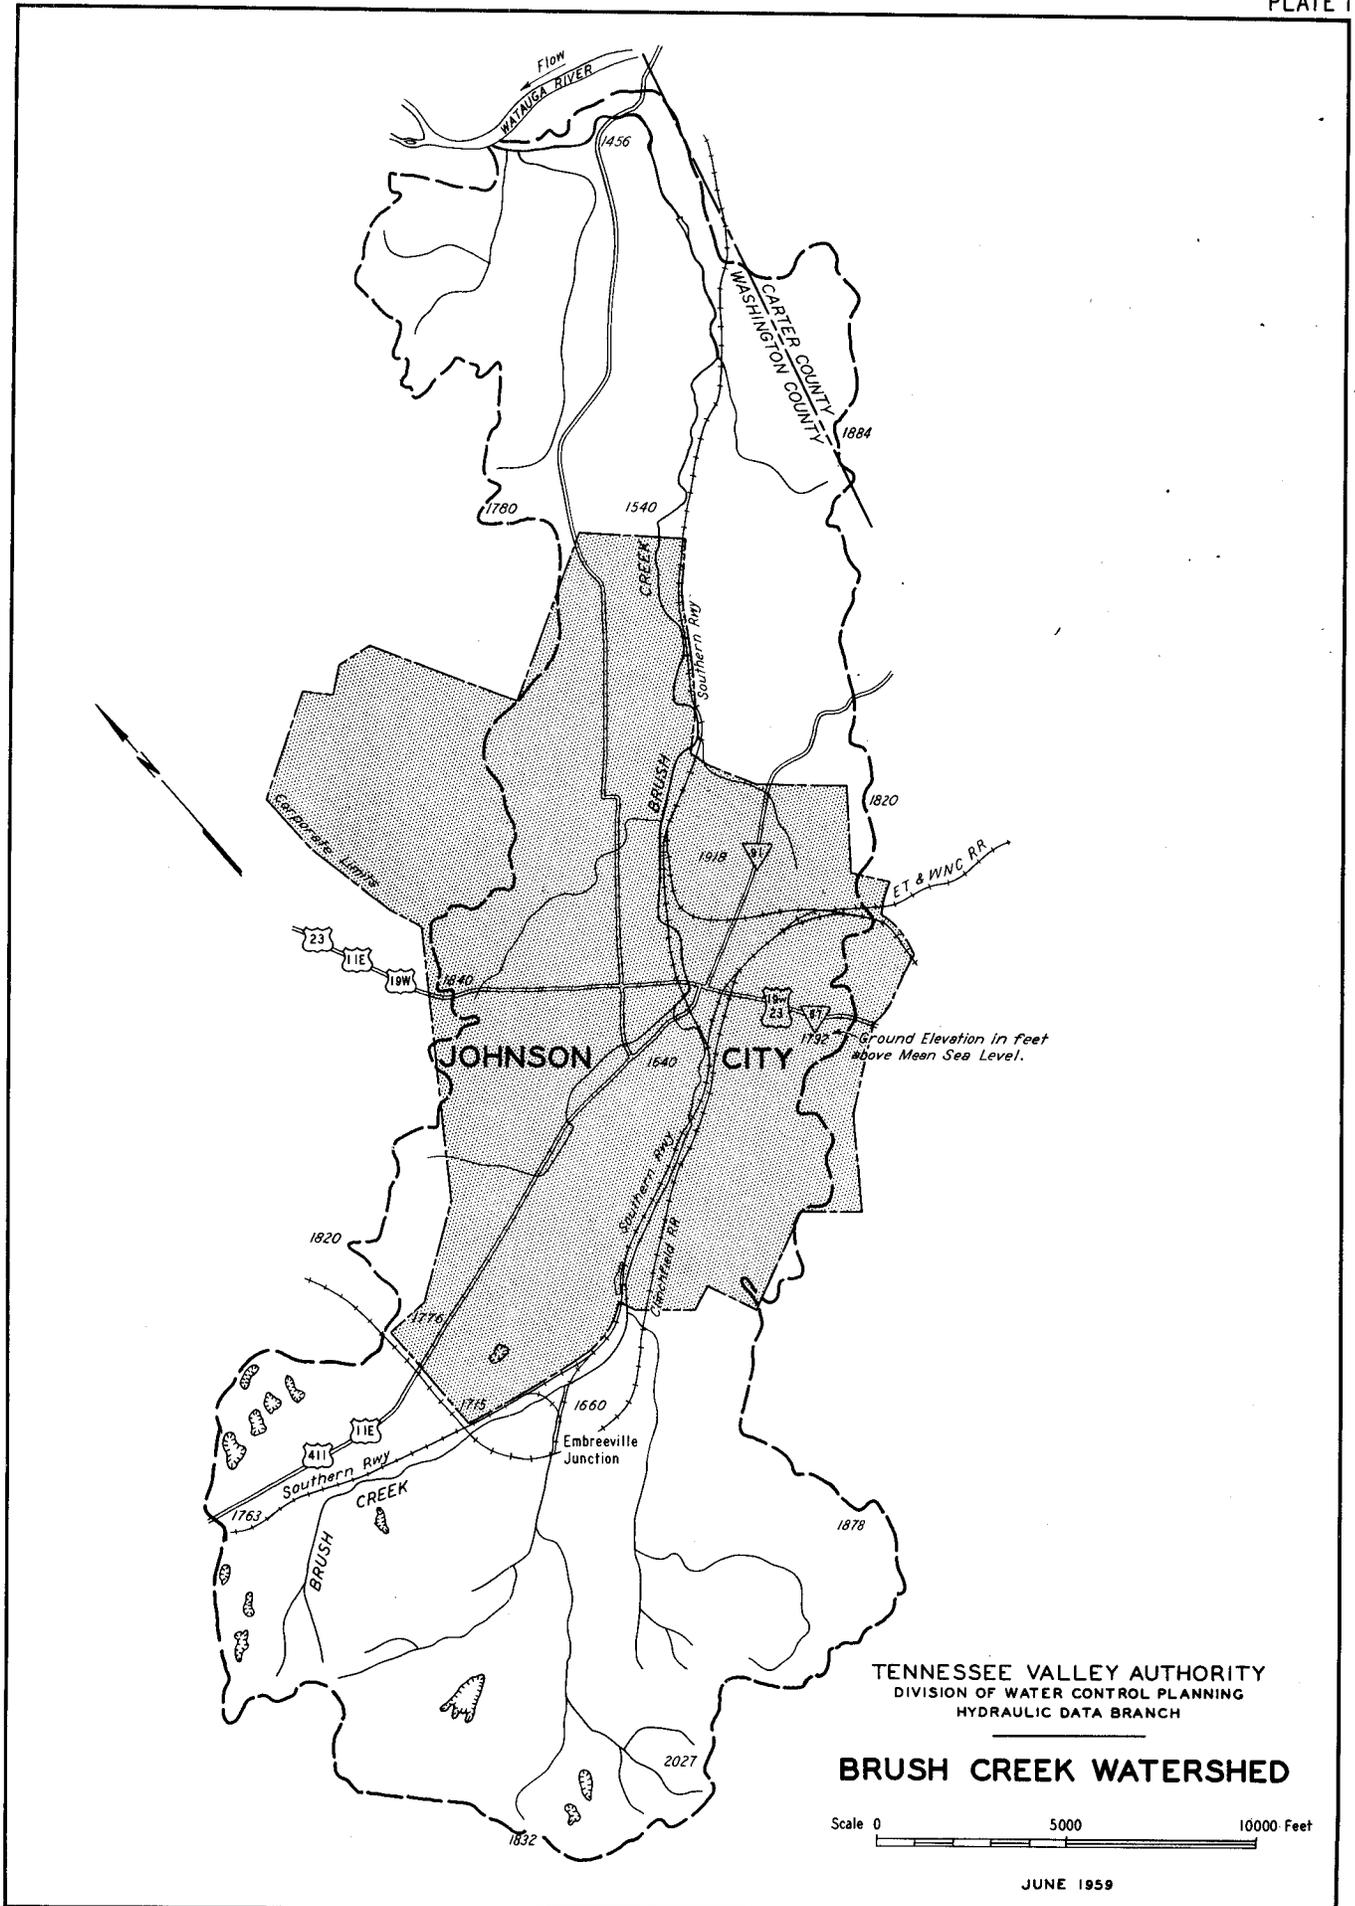
BRUSH CREEK WATERSHED

The Brush Creek watershed shown on Plate 1 is long and relatively narrow with rolling topography most of which is cleared. However, above Johnson City, the area is somewhat fanshaped with three branch streams

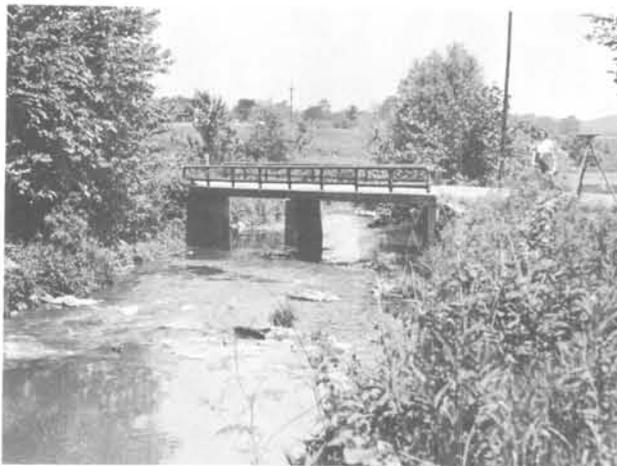
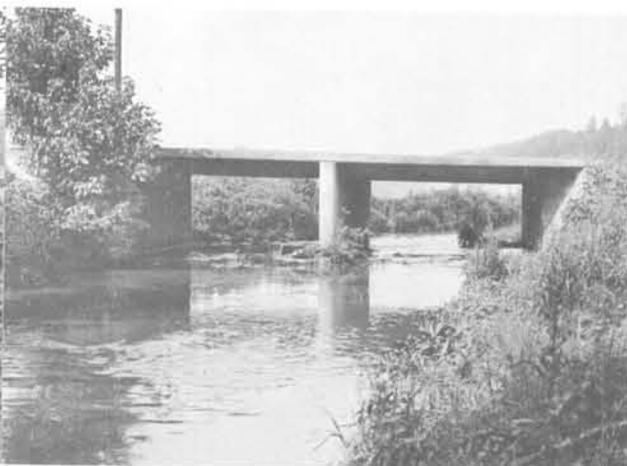
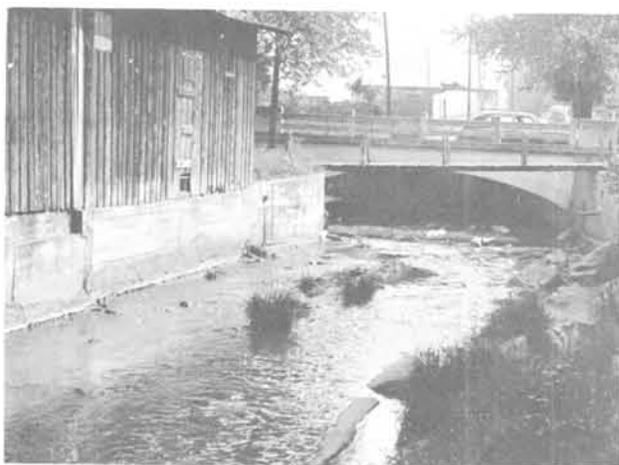
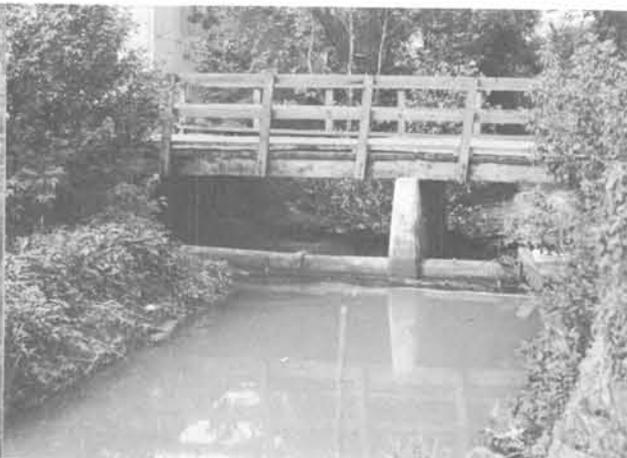
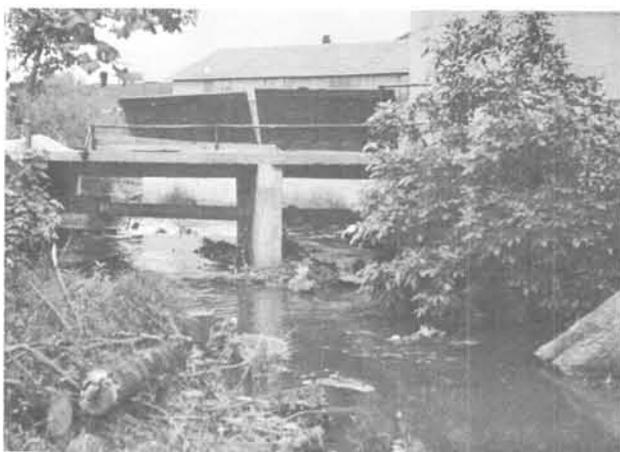
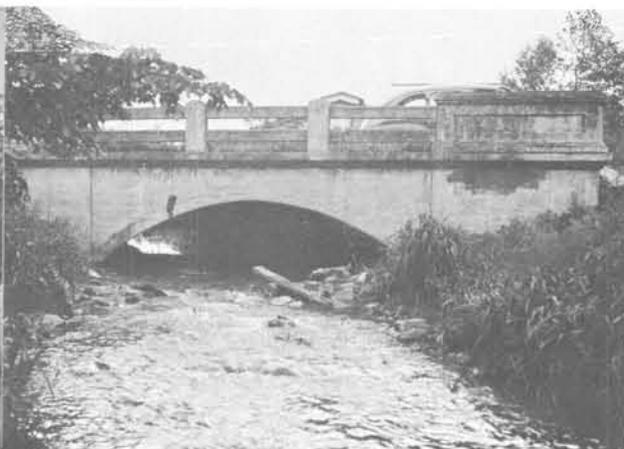
Figure 2. --STREET CROSSINGS OF BRUSH CREEK

Fairview Street

Broadway

Oak Street
and walled channel downstream

Elm Street

Sevier Street
and pipe obstructing opening

Watauga Avenue

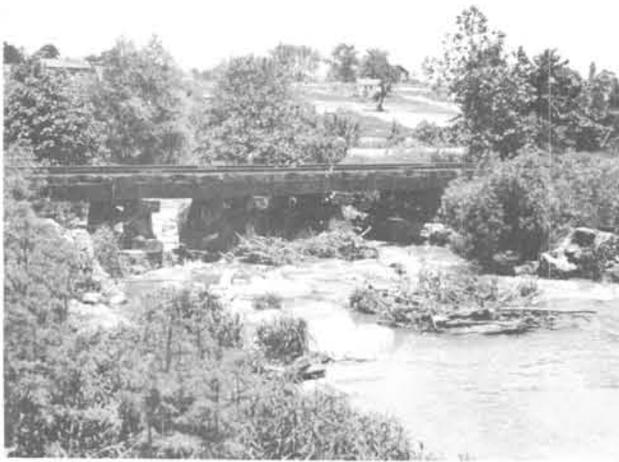
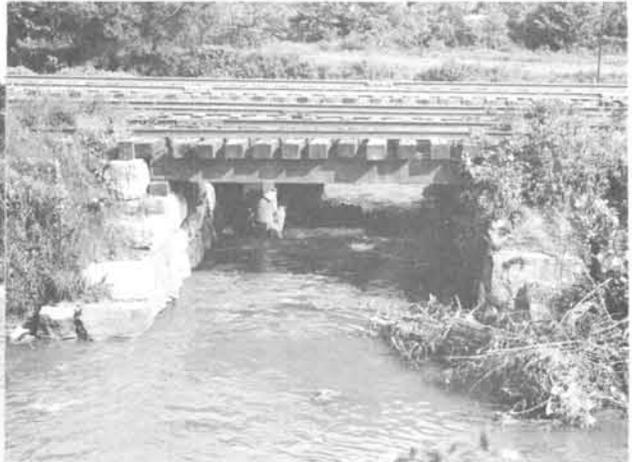
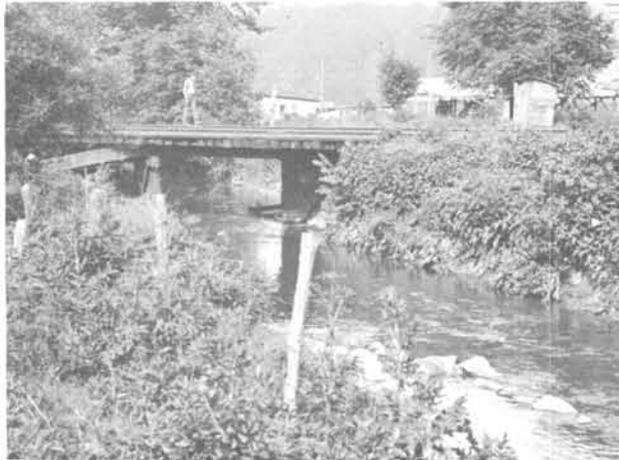
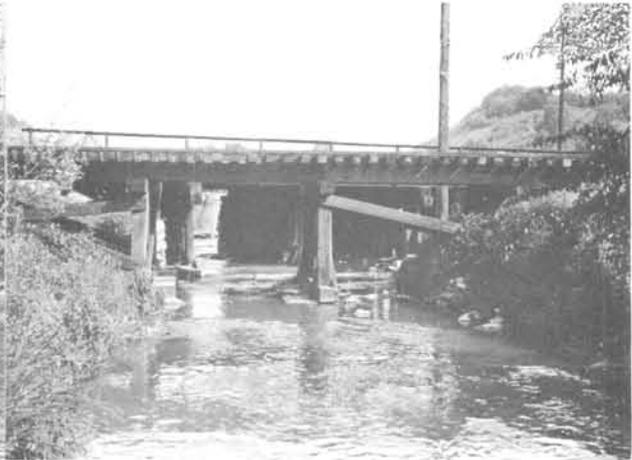
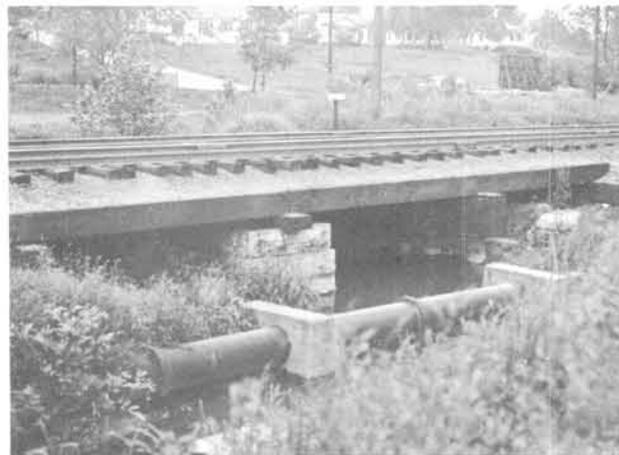
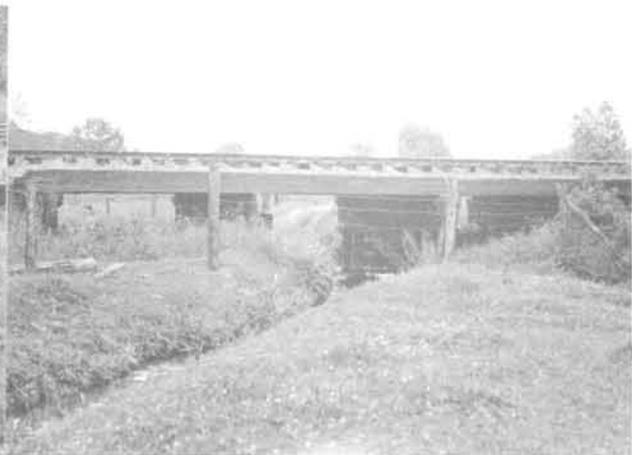
Figure 3. --RAILROAD CROSSINGS OF BRUSH CREEK

Spur crossing half mile above Fairview Street

Southern Railway main line and spur crossing below Broadway

Spur crossing quarter mile above Broadway

Spur crossing above Oak Street

Southern Railway crossing above Watauga Avenue

Spur crossing below Embreeville Street

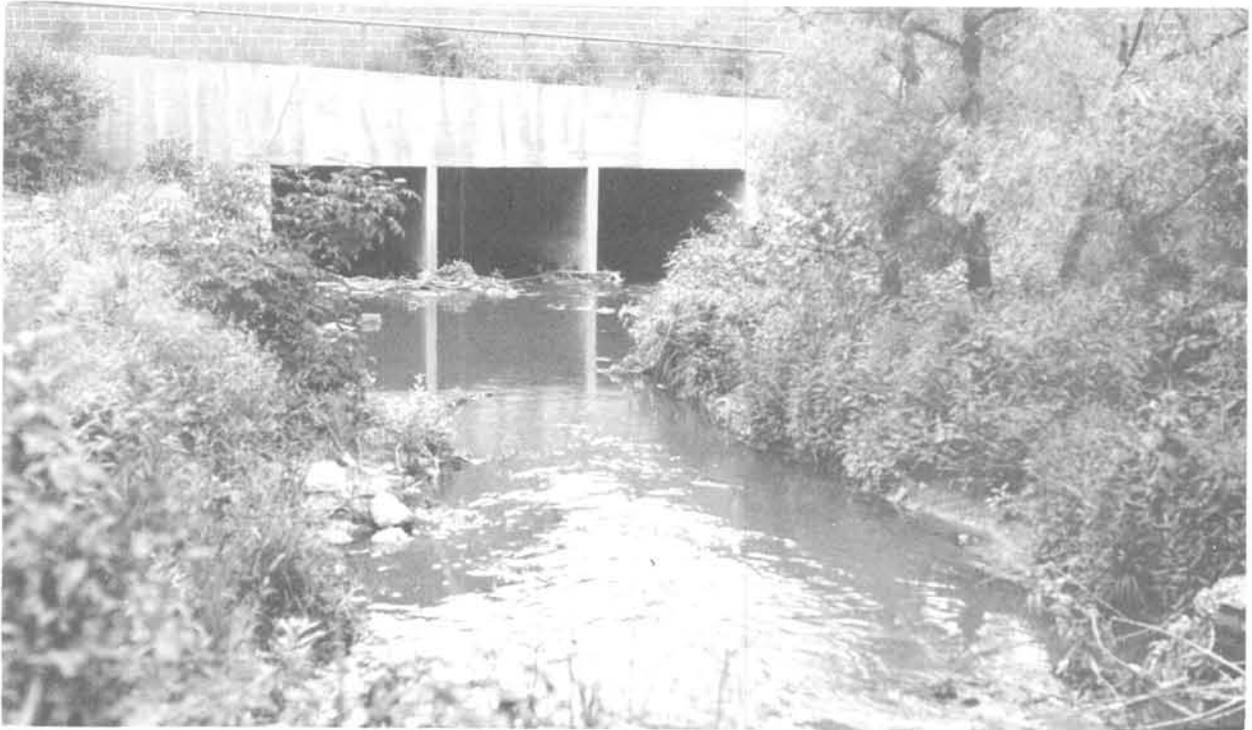
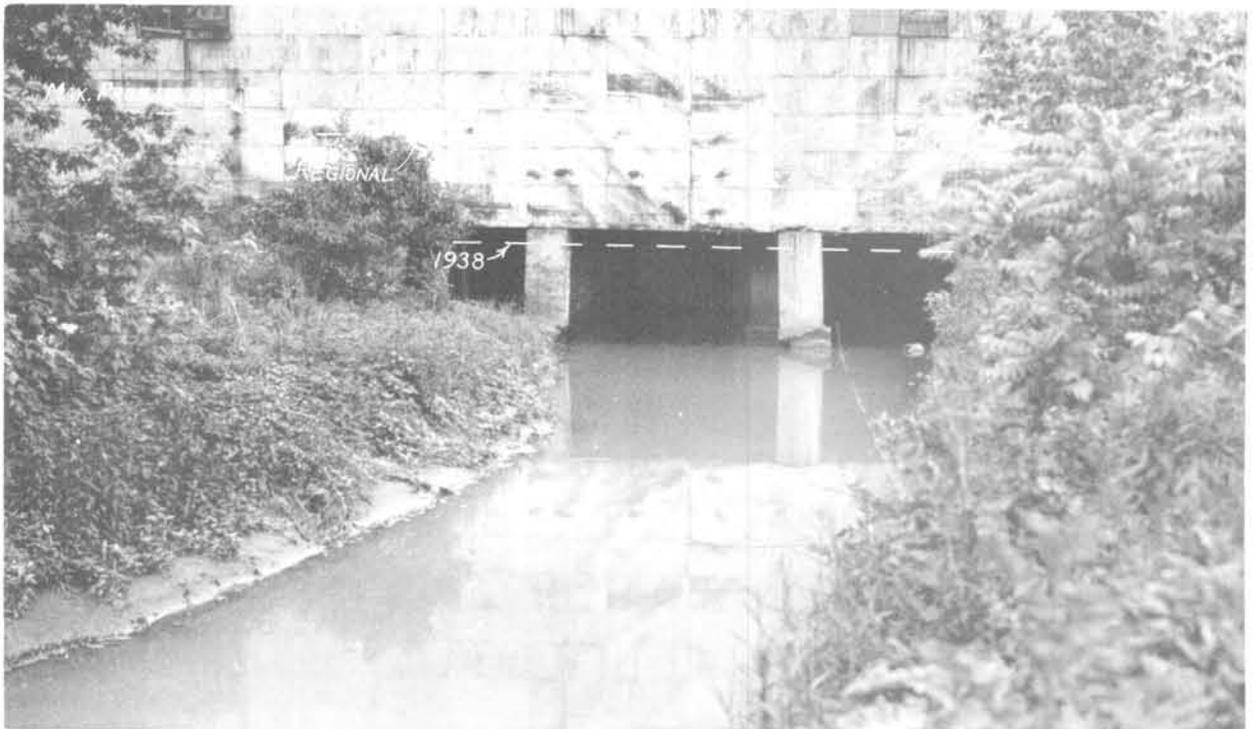
Figure 4. --COVERED SECTION OF CREEK - MILE 6.40 TO MILE 5.77

The upper view is the entrance to the covered section of Brush Creek near Sevier Street. This extends for 3370 feet to the outlet below Roan Street which is shown in the lower picture. Columns supporting buildings over the creek obstruct flow of the creek. The upstream 700 feet of this section was built after the 1938 flood. The lower view shows the height of the 1938 flood, and of the Regional and Maximum Probable Floods discussed respectively in Sections II and III.

7. A length of 3,300 feet of the creek is covered through the central part of the city. The capacity of this is inadequate to carry large floods without overflow. Where buildings are located over the covered creek section, the columns supporting the building floors tend to obstruct the flow of water.

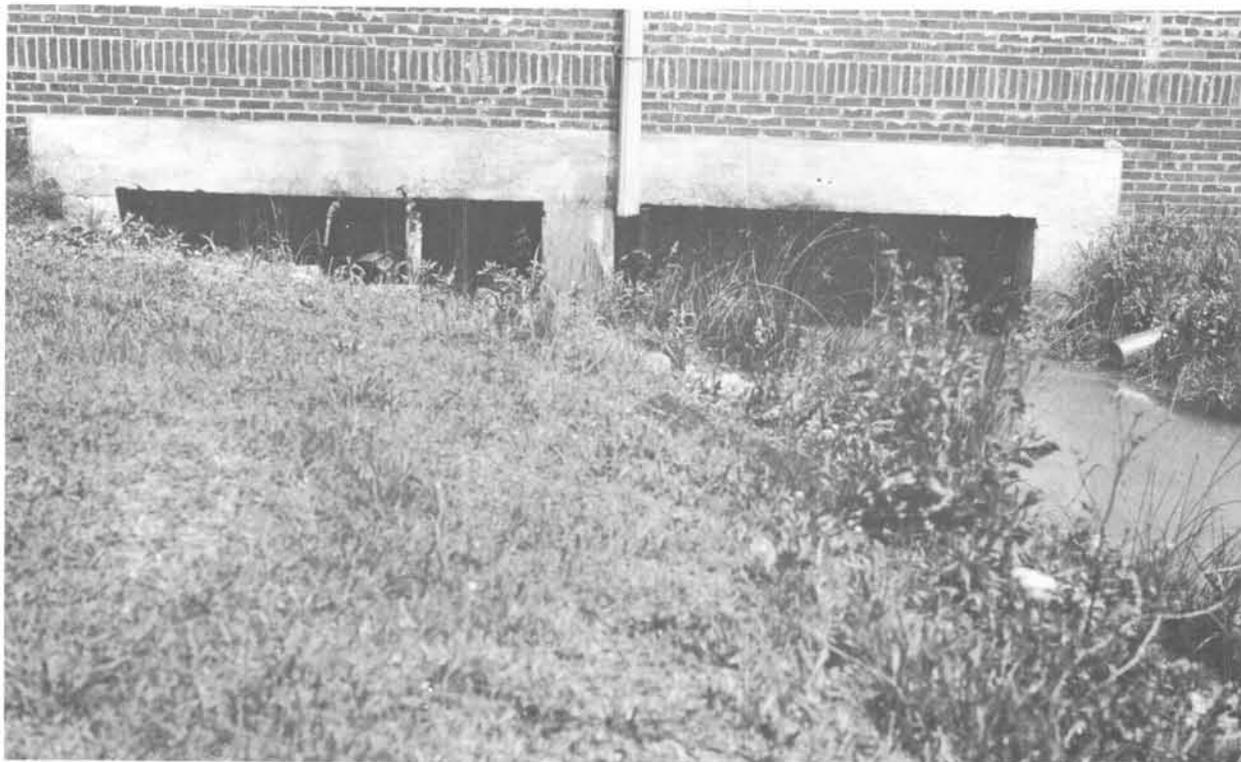
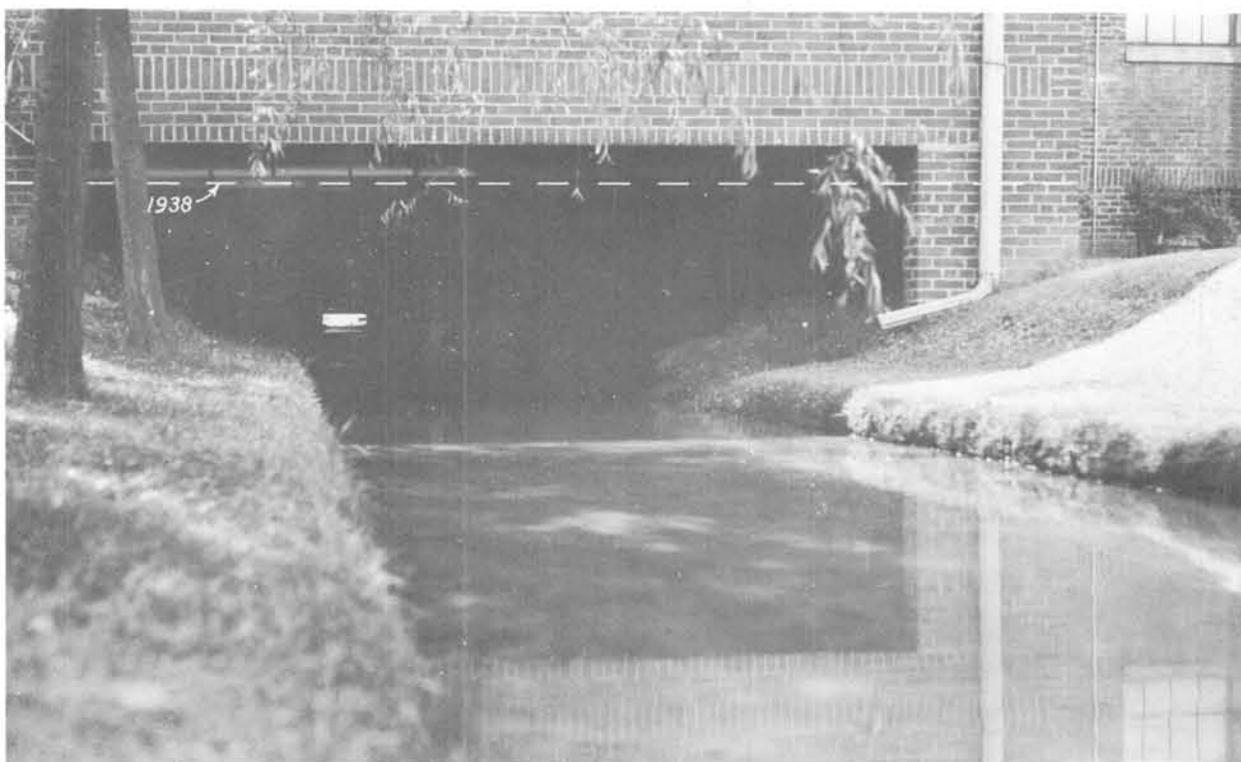
Figure 5. --BRUSH CREEK CHANNEL UNDER GLORIA MILL

The creek flows for 340 feet under the Gloria Rayon Mill. The upper picture is the entrance and the lower picture is the outlet. The lower view shows the height of the 1938 flood.

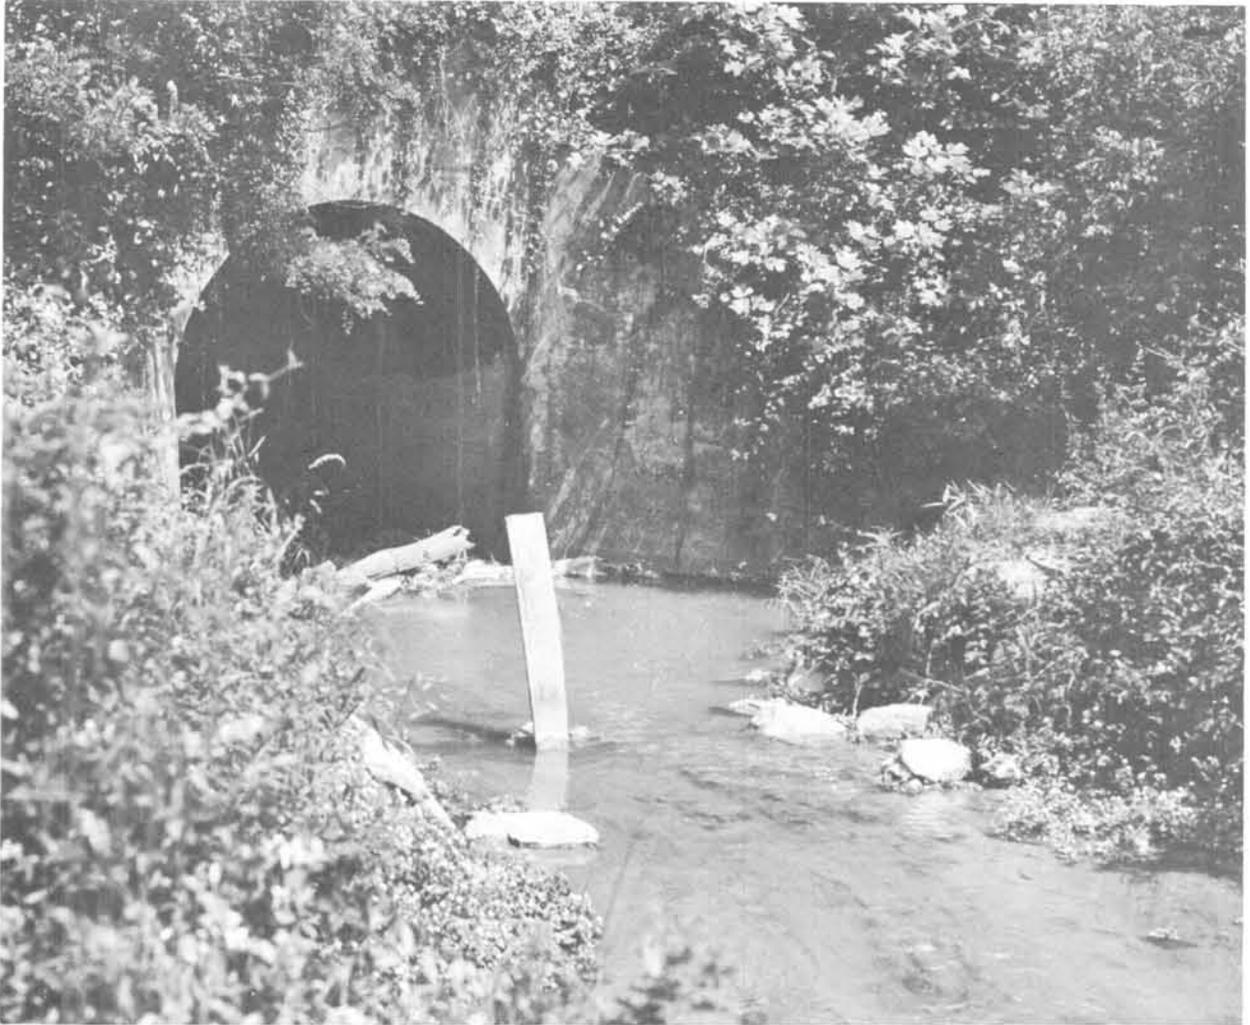
Figure 6. --RAILROAD CULVERT AT MILE 8.76

Brush Creek flows under the Clinchfield Railroad embankment through a culvert 102 feet long. Large floods would be headed up and flood water ponded on the upstream side of the 16 feet high embankment.

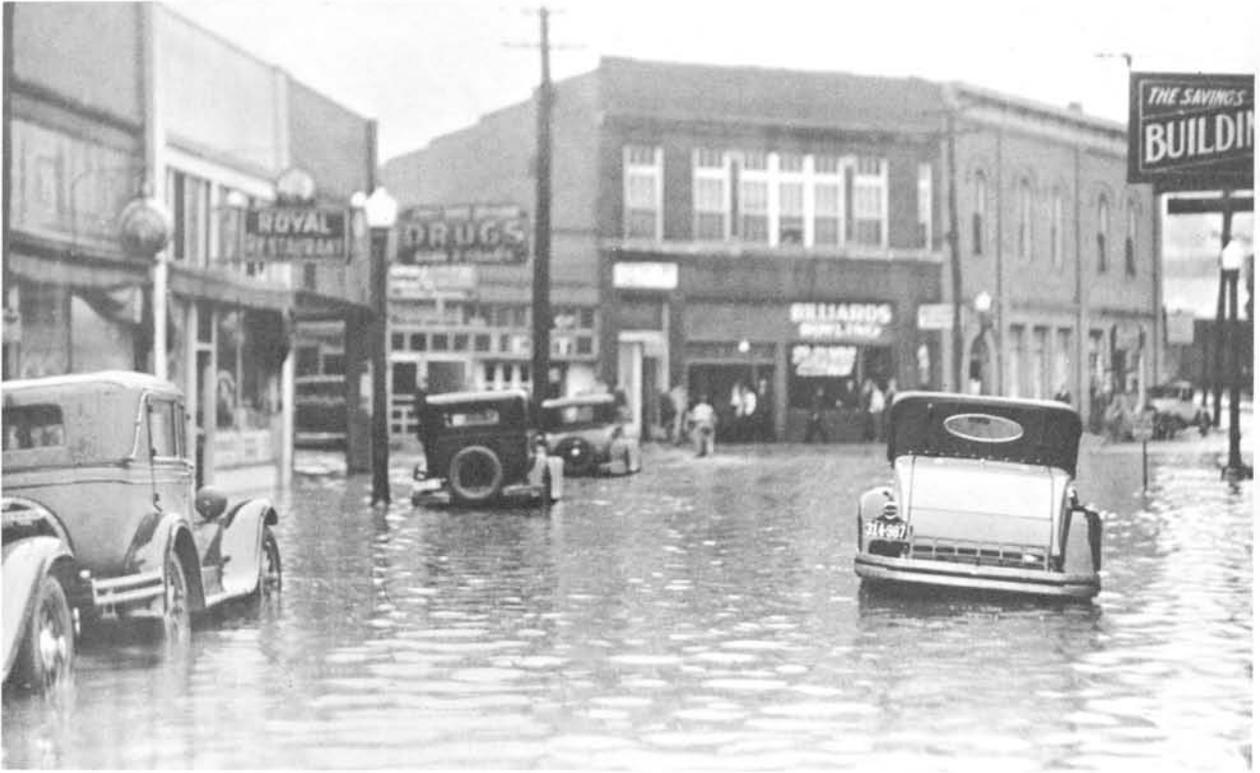
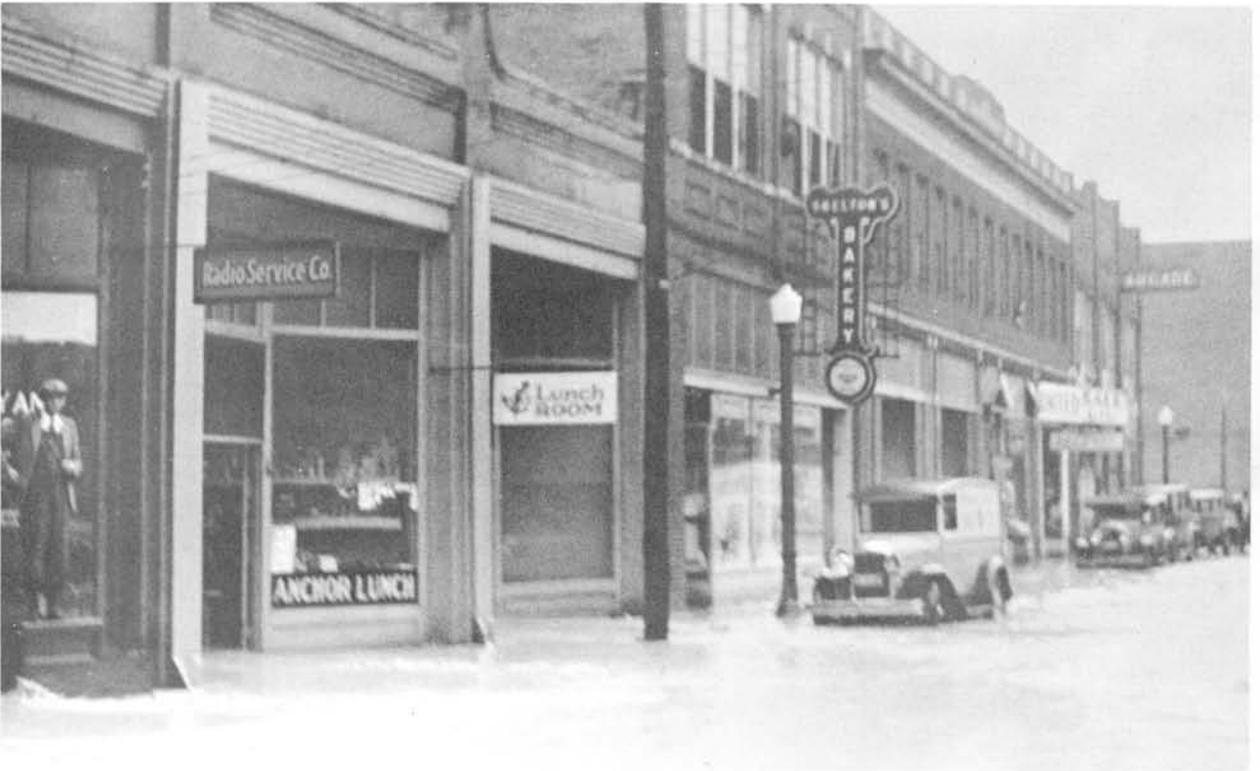
Figure 7. --SUMMER FLOOD IN 1932

The upper view is along Buffalo Street looking toward the intersection with Tipton Street. The lower view is looking west on Market Street from the Arcade Building.

Photographs obtained in 1938 by Hydraulic Data Branch engineers from the Burr Harrison Studios in Johnson City show a flood which occurred in the summer of 1932, probably just prior to installation of the staff gage by the U. S. Geological Survey in June. Elevations estimated from these photographs show that the flood was almost identical with that of September 1922. No newspaper references were found for this flood and no data have been located regarding this flood other than the photographs, two of which are reproduced in Figure 7.

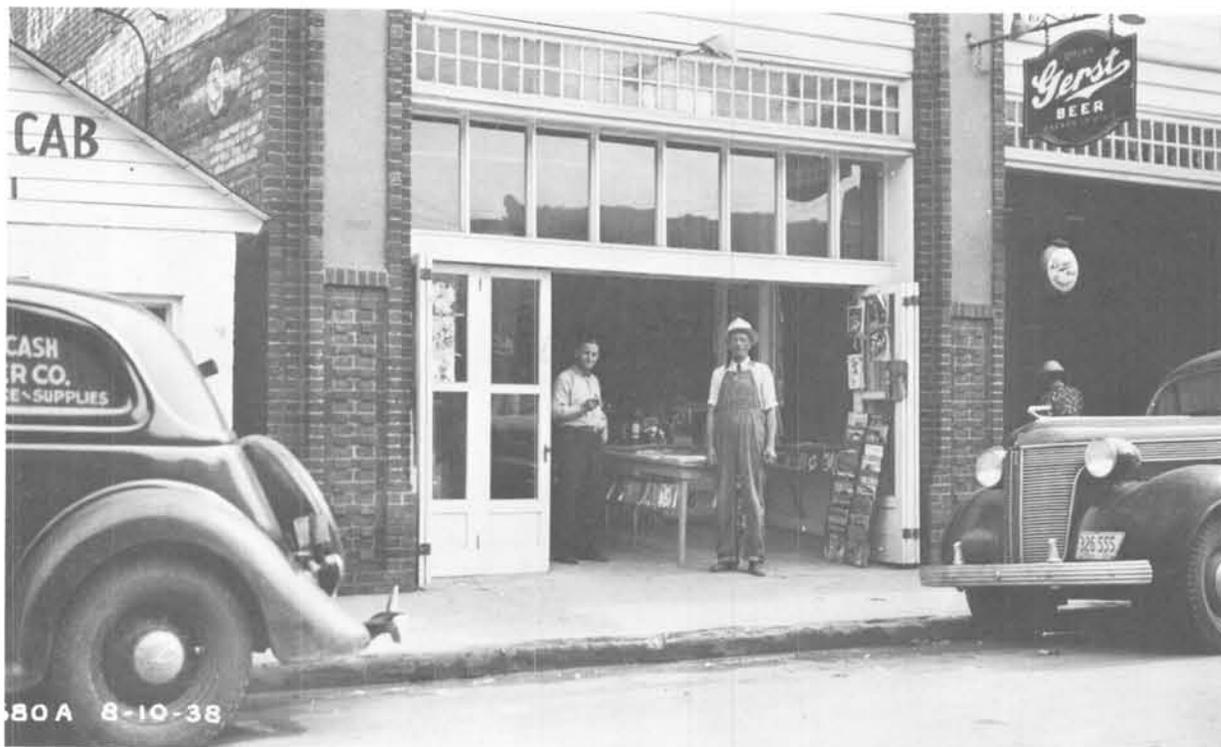
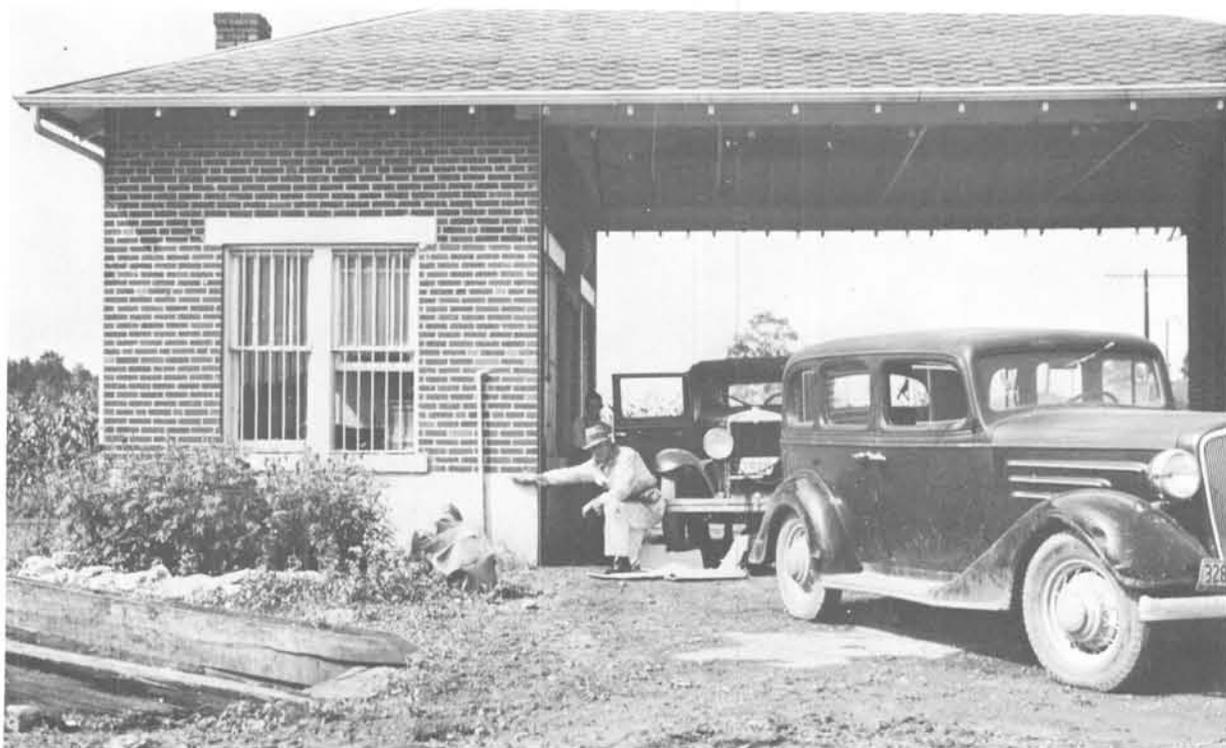
Figure 8. --THE MORNING AFTER THE 1938 FLOOD

Upper view shows Main Street entrance to Arcade Building. At the crest, the water came to within 2 inches of the glass in the doors. This building is set over the creek, and water flowed through the building during the flood. The lower view is a filling station near the highway underpass of the Clinchfield Railroad near the Soldiers' Home. The man is pointing out the flood height at the crest.

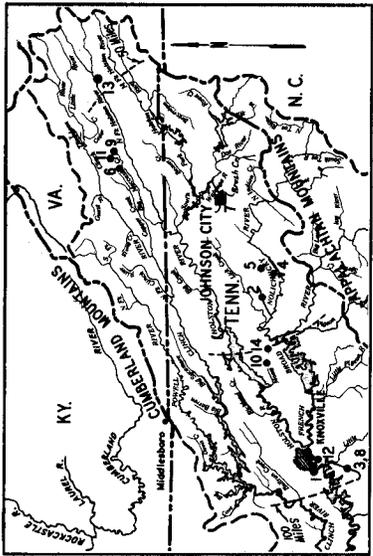
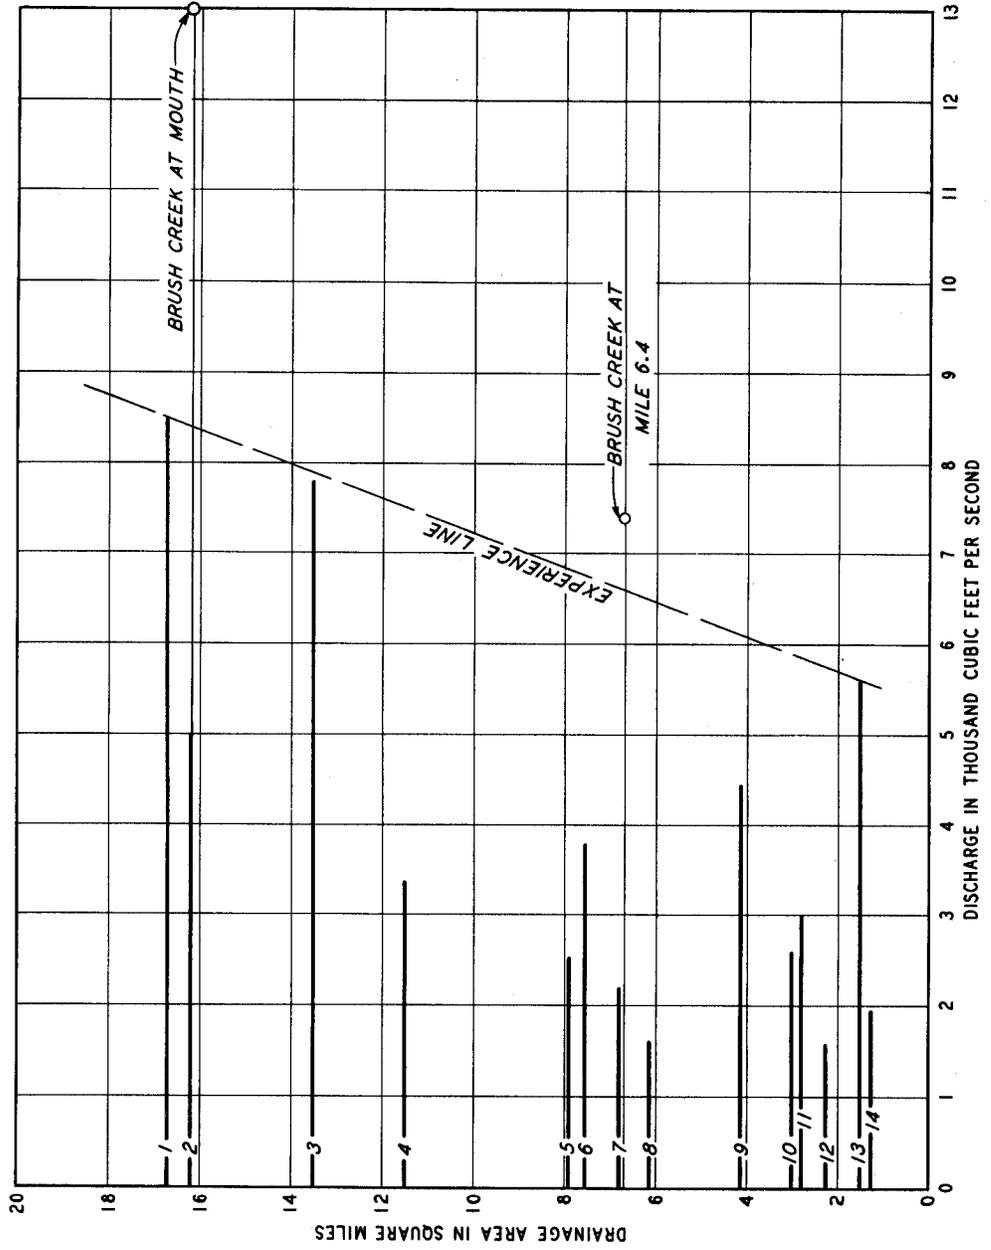
**MAXIMUM KNOWN
FLOOD DISCHARGES**

KEY MAP
Scale 0 20 40 60 Miles

Numbers on chart refer to those on Key Map and in Table 4.
O--- Estimated Maximum Probable Flood determined by Flood Control Branch.
