TENNESSEE VALLEY AUTHORITY
DIVISION OF WATER CONTROL PLANNING

FLOODS ON BRUSH CREEK
IN VICINITY OF
JOHNSON CITY TENNESSEE

REPORT NO. 0-5868

KNOXVILLE TENNESSEE
JUNE 1959

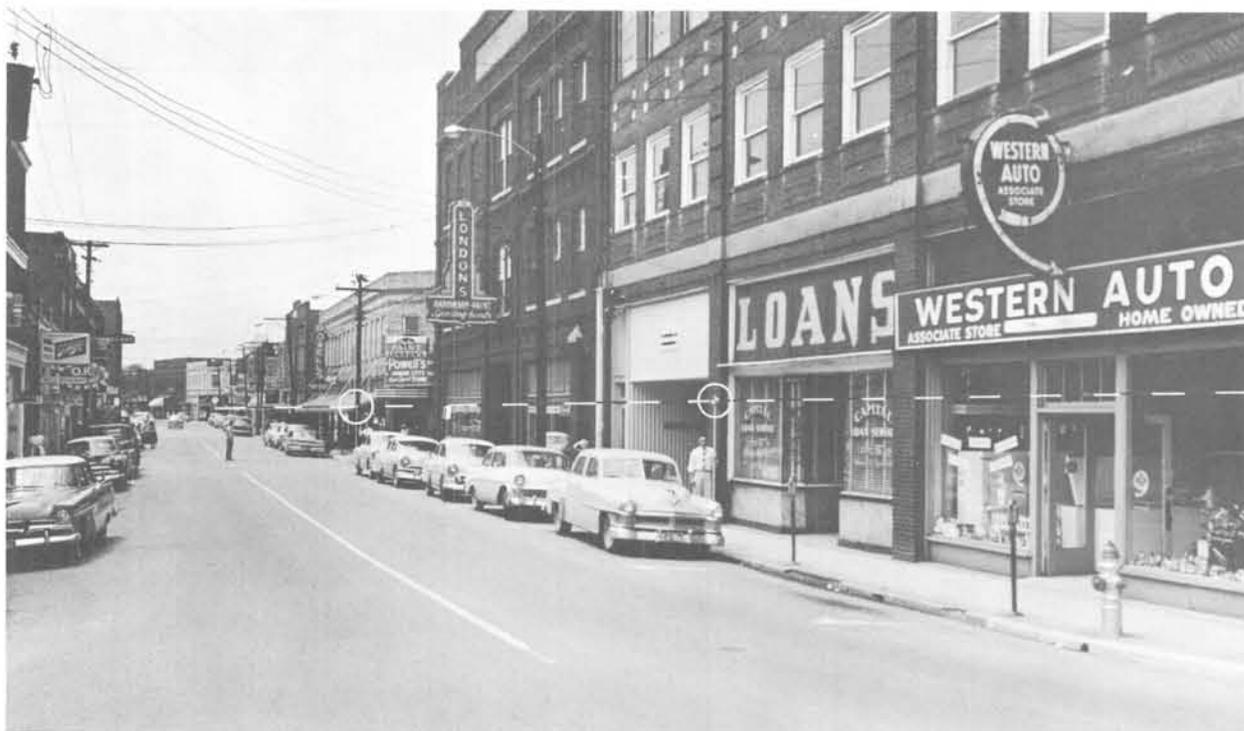
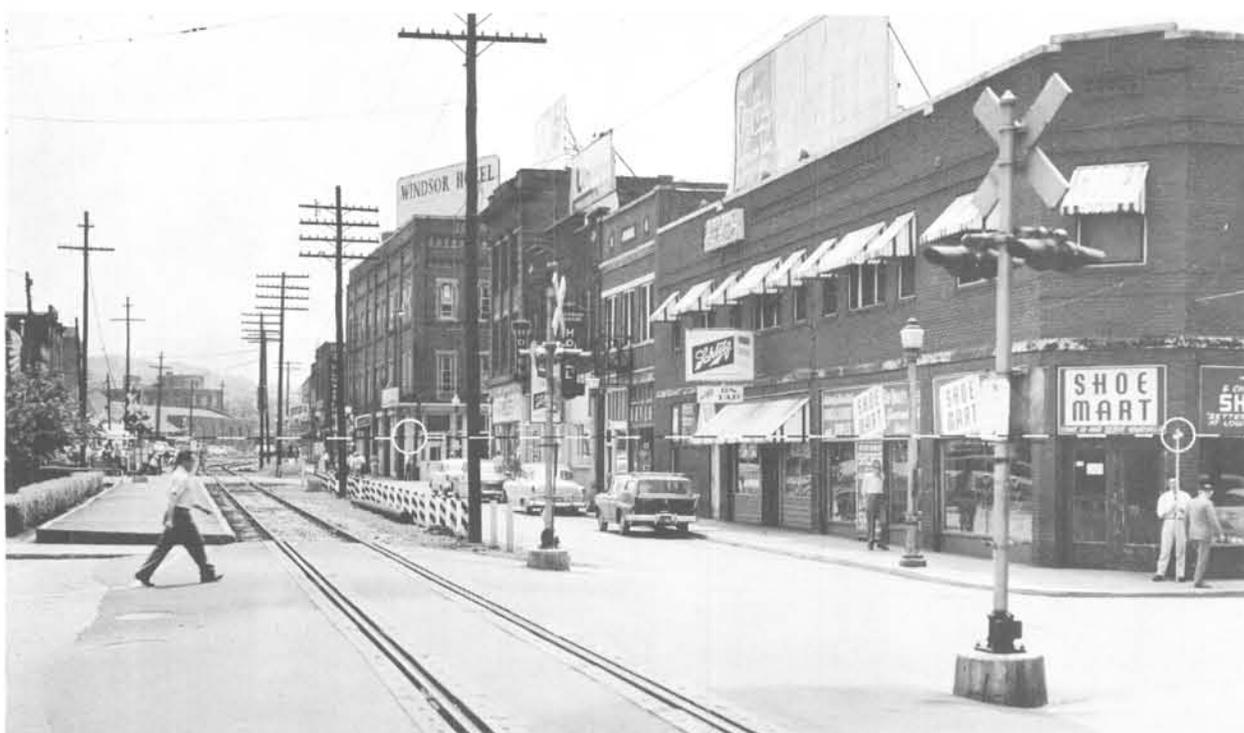
Figure 9. --MAXIMUM PROBABLE AND REGIONAL FLOOD HEIGHTS IN FOUNTAIN SQUARE AREA

The upper view is west along Market Street from the Southern Railway crossing. The lower view is south along the Southern Railway and Windsor Street from the south end of the station platform. The white circles and dashed lines show the height of the Maximum Probable Flood discussed in Section III. The Regional Flood height is 10 inches lower.

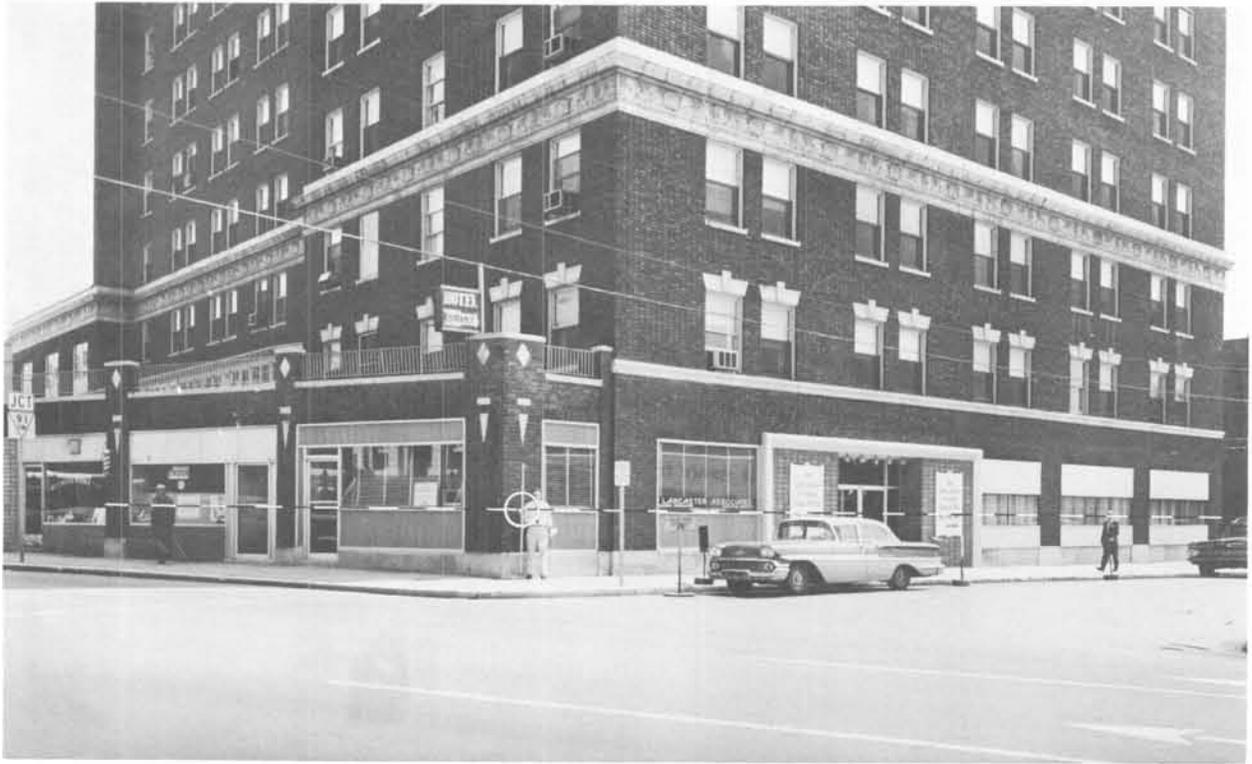
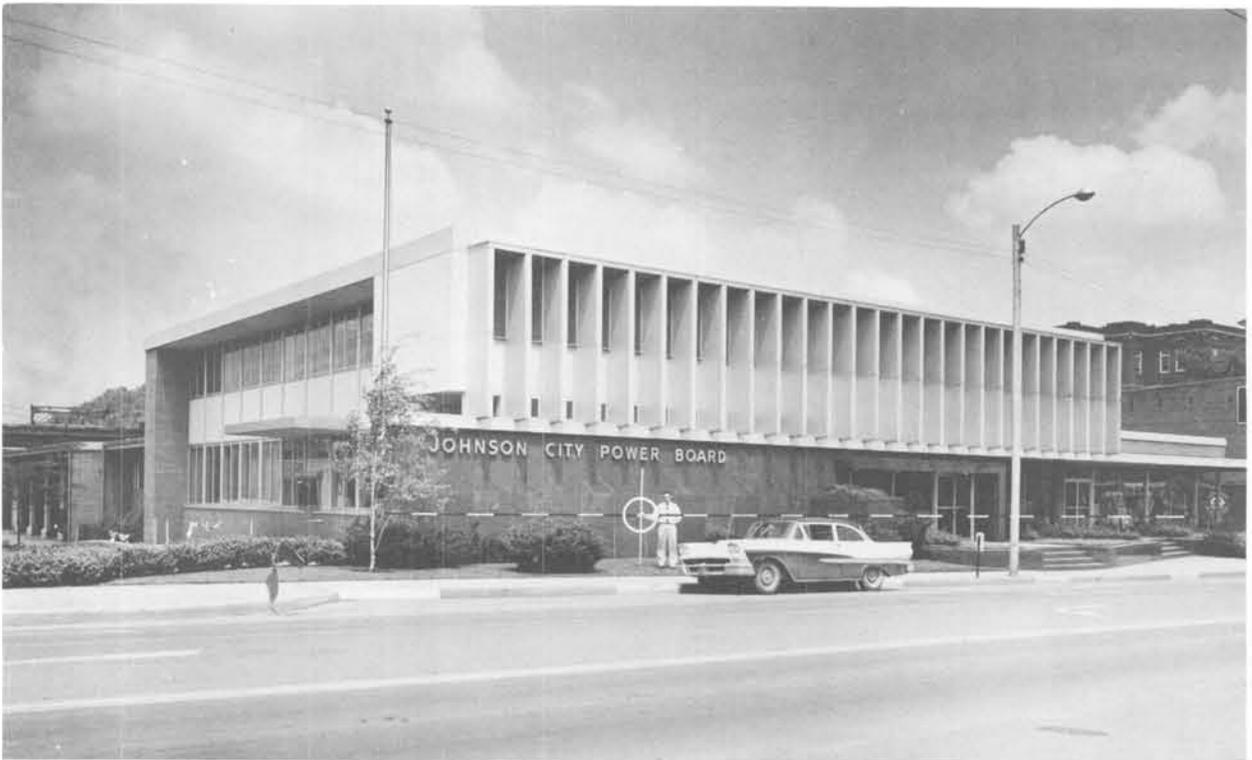
Figure 10. --FLOOD HEIGHTS AT HOTEL AND POWER BOARD BUILDING

The upper view shows the John Sevier Hotel on Roan Street. The lower view shows the Johnson City Power Board building. The white circles and dashed lines are at the height of the Maximum Probable Flood discussed in Section III. The Regional Flood height is 10 inches lower.
